# Nano-Ceramic Modified Polymer Matrix Glass Composites for Impact Applications

Harish Kallagunta<sup>1</sup> and Jitendra S. Tate<sup>2,\*</sup>

*SAMPE Conference Proceedings. Charlotte, NC, May 20-23, 2019. Society for the Advancement of Material and Process Engineering – North America.*

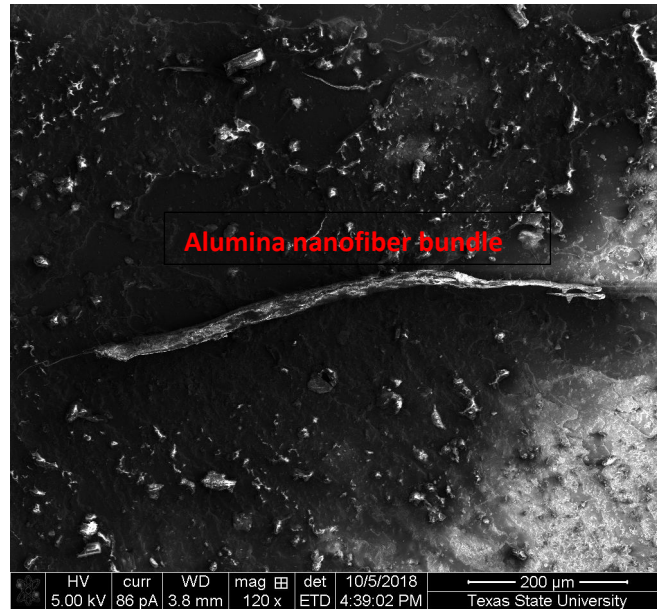
Fig 2: SEM image of alumina nanofiber modified UPE

Fiber volume fraction in all the four different laminates is in the range of 57-59%. Low velocity impact properties are analyzed in terms of energy absorbed and damage area to see the effect of nanosilica and alumina nanofiber nanoparticles on the impact properties of the E-glass/epoxy and E-glass/UPE composites. The summary of the energy absorbed values are given in table 3. It can be seen from the values that the E-Glass/UPE nanocomposites have considerably higher values of energy to max load indicating than the E-glass/Epoxy nanocomposites. This indicates that the E-glass/UPE composites absorbed more energy before failure. Even when compared between the nanosilica and alumina nanofiber modified epoxy composites, the nanosilica modified epoxy composites showed greater energy absorption before failure. Obviously, improved energy absorption of composite laminates is attributed to the load transfer capability between matrix and nanoparticles. This effective stress transfer between matrix and nanoparticles is strongly dependent on the dispersion techniques. Since the E-Glass/UPE composite samples showed higher energy absorption but there was not an improvement in the energy absorption even with addition of alumina nanofiber samples, the samples were imaged using SEM. The SEM image revealed that the matrix contained agglomerated nanofibers, suggesting that the dispersion needs to be more effective.

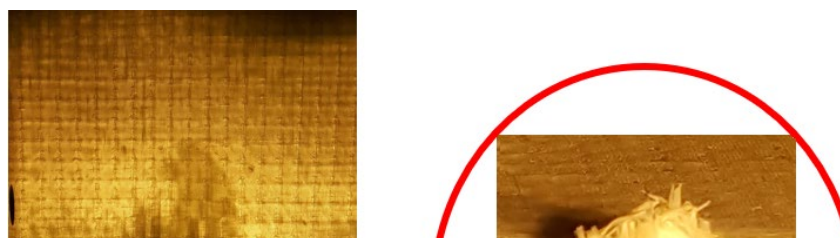
Fig 12: Damage on the opposite side of impact of the 20wt% nanosilica modified epoxy glass composite panel. The image in the inset showing fiber fracture.

Damage in E-Glass/Epoxy composite system: The 2.5wt% alumina nanofiber modified epoxy glass composites and 20 wt% nanosilica modified epoxy glass composites have failed completely. In both the material systems, the energy dissipation is very inadequate, and the damage is restricted to the region close to the impactor. The alumina nanofiber and nanosilica changed the matrix fiber interface that the damage progression was arrested, and the energy is spent in damaging the sample in through thickness direction. The back face in the epoxy-based nanocomposites experienced extensive damage showing clear penetration with fiber breakage. No widespread delamination, matrix cracking or fiber distortion in the epoxy-based nanocomposites is observed. Fig 9 and Fig 10 show the impactor side and back side damage in the 2.5wt% alumina nanofiber modified epoxy glass composites respectively. The impactor side image reveals that the impact energy was absorbed mainly to overcome the compression below the impactor. The image also reveals that the cracks are initiated and propagated in all the four directions but are limited around the impactor. The matrix crack and delamination are also observed to be around the impactor region. Fig 11 and Fig 12 show the damage in front side and back side of 20wt% nanosilica modified epoxy glass composites respectively.

In comparison between alumina nanofiber modified epoxy glass composite and the nanosilica modified epoxy glass composite the damage is more widespread in the later as opposed to the restricted damage area in the earlier. The fiber morphology of the alumina nanofibers has shown greater extent of damage restriction by constraining the cracks to propagate further along the axial direction in the nanocomposite. The spherical morphology of the nanosilica particles have less area for the crack to deviate and propagate further.
