# MANUFACTURE AND COMPRESSION TESTING OF A MACHINED COMPOSITE MECHANICAL SYSTEM

Thomas J. Rohrbach, Eltahry Elghandour

California Polytechnic State University, San Luis Obispo  
Mechanical Engineering Dept.  
San Luis Obispo, California

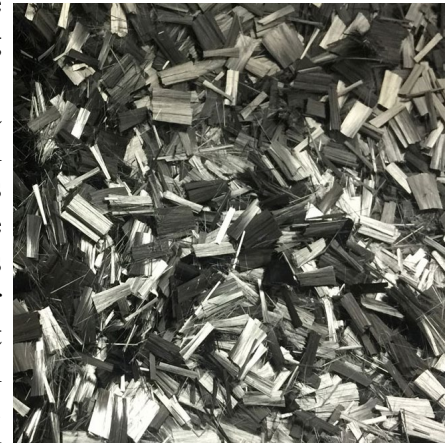
**Figure 2** – Chopped carbon fiber [3]

The advantage of exploring the two unique materials mentioned previously is their quasi-isotropic material behavior, meaning that the material exhibits nearly the same elastic properties regardless of the direction of in-plane loading. This is accomplished by the equal angular separation in the triaxial weave, and the random, discontinuous nature of the chopped fibers. This serves to benefit the concept of compression molding the material for machining geometry and maintaining favorable material behavior along the loading axis.

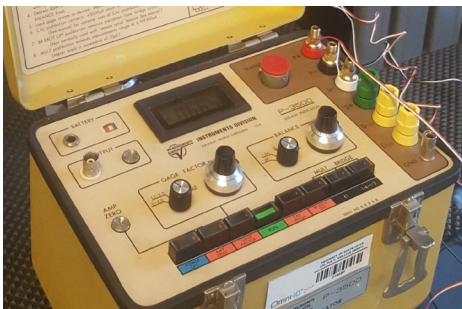
**Figure 6** – Strain gauge box

The steel component was tested using an Instron hydraulic system. The system was instrumented with a load cell and a DAQ to display force readings. Strain gauge measurements were taken using a quarter bridge configuration through a strain gauge box, pictured in Figure 6. The rod shown in Figure 4 was mounted to the custom fixtures shown in Figure 7 to ensure proper loading on the specimen.

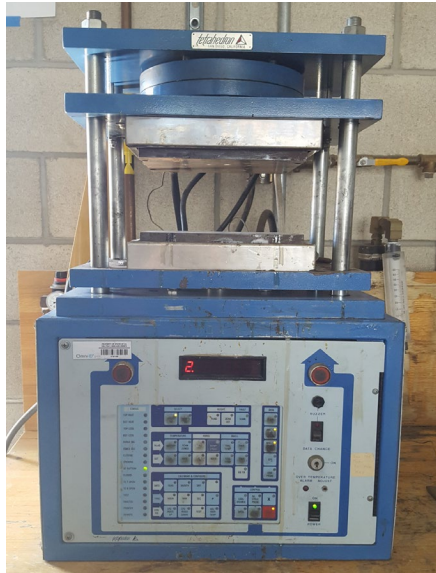
**Figure 10 – Composite press**  
The composite materials utilized were cured using the Cal Poly Aerospace Engineering composite press (pictured in Figure 10). The cure cycle for the triaxially woven material can be seen in Figure 11 while the chopped fiber material's is pictured in Figure 12. The shortest cure cycle for the HX42 (Figure 11) was elected to allow for rapid iterating and production.

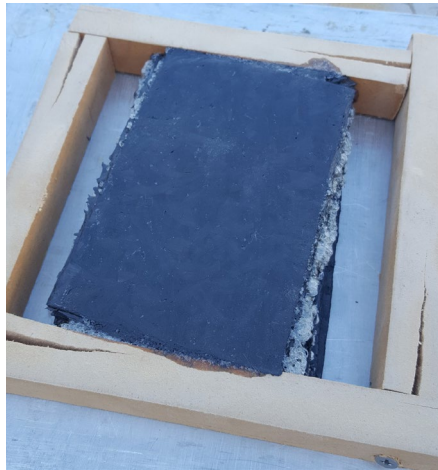
Figure 15 – MDF mold attempt

As lateral constraints proved to be necessary to maintain perpendicularity between walls on the mold, MDF was elected for the next iteration. Segments were cut to the desired final brick height and screwed together after drilling pilot holes. Small cracks formed as a result of the screws being inserted, which propagated further after the cure as a result of the pressure applied

from the composite press (visible in Figure 15). Although the mold stayed assembled, the cracks implied deformation in the thickness direction and caused concern about the repeatability of achieving the right thickness when curing machinable bricks. Because of the concern of consistency between cures, time was invested to machine a fully aluminum mold.

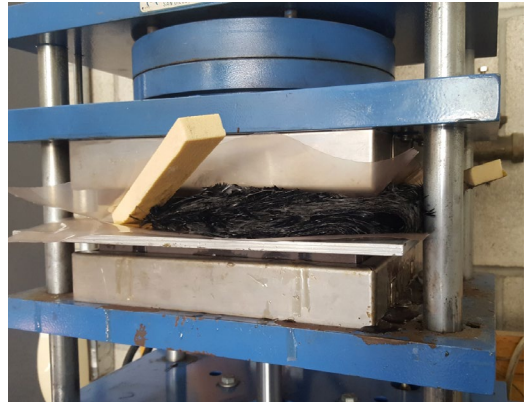
Figure 14 – HDF cure failure

The result of the cure cycle can be seen in Figure 14. This iteration revealed that the chopped material ran significantly due to discontinuous nature of the fibers. Additionally the pressure exerted on the heated vacuum tape and foam segments rotated

the walls, thereby allowing the structure to be crushed edgewise and demolish the perpendicularity between the walls. Because of the issues of material containment and wall integrity a follow up iteration was conducted using medium density fiberboard (MDF).

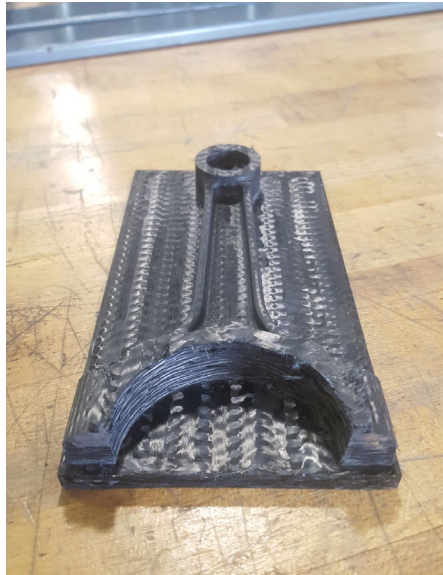
**Figure 28** – Machined geometry after OP1

CNC tool paths were generated and verified prior to machining using MasterCAM. Bricks were lightly sanded to clean edges and any extraneous material prior to being placed into the vice. The CNC process was split into two operations: OP1 containing the part roughing and finishing passes through half of the geometry in the part Z direction (pictured in Figure 28), and OP2 completing the geometry on the opposite half. The second operation therefore required an aluminum soft jaw matching OP1 geometry. Coolant was not used from the mill. Instead the cutter was intermittently sprayed with water to prevent overheating. To control carbon particulate a vacuum was kept pointed at the tool path which limited any airborne dust or contamination into the mill's moving parts.

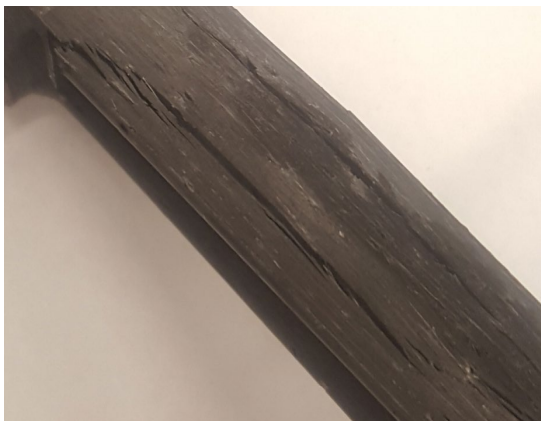
**Figure 32** – Chopped rod failure

The failure mode experienced by the chopped fiber rod is shown in Figure 32. This can be compared with the failure mode of the woven rod portrayed in Figure 33.

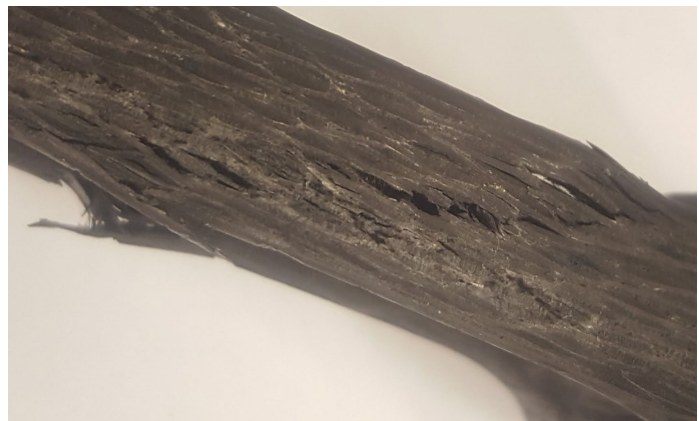
**Figure 33** – Woven rod failure
