# REMEDICATION OF CONTAMINATED BOND SURFACES: CONTAMINANT MIXTURES

R. Giles Dillingham, Brooke Campbell, Matthew Nichols  
BTG Labs  
Cincinnati, OH/USA

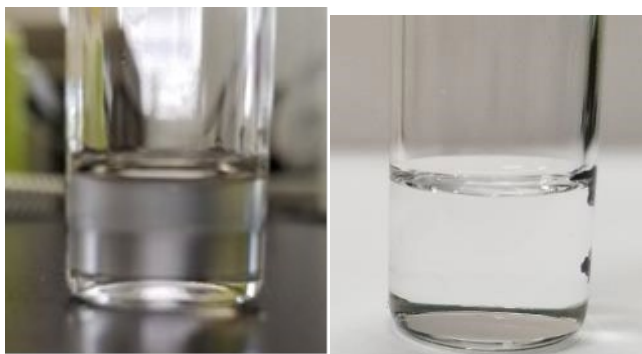
**Figure 1.** Initial evaluation of silicone solubility in candidate solvent. Left: silicone immiscible in solvent. Right: silicone miscible in solvent.

Motor oil is readily removable by a variety of solvents, both polar and non-polar. Silicones are much more problematical due to their lack of solubility in most solvents. Solvents were prescreened for their ability to solubilize silicones by blending 3 ml each of silicone oil and the candidate solvent in a glass vial, capping and shaking until dispersed. The mixture was then allowed to sit for several minutes and then visually evaluated for phase separation (Figure 1). Solvent/silicone mixtures that showed evidence for phase separation were not evaluated further. Quantification of the ability of these solvents to remove silicone from a surface was evaluated by comparing infrared spectra from contaminated ferrotype plate (chrome-plated steel) before and after successive wet + dry wiping cycles. Absorbance is directly proportional to the thickness of the silicone film on the surface and is a quantitative indicator of the ability of the given solvent to remove silicone from the surface. American Fiber and Finishing Rymplecloth™ was the wiper used for both wet and dry wiping. The best performers (MEK, decane, hexane, and ethyl acetate) all gave very similar results; ethyl acetate was chosen for further evaluation because it was the best performer.
